Industrial Crack Inspection Copter

Abstract: The purpose of this paper is to present a study that aims to employ copters for the Inspection of Chimneys/ Industrial exhaust vents in high rise buildings where human intervention may prove risky. Concretes are popular material used for constructing Chimneys; concrete chimneys require routine observation and maintenance to ensure trouble-free operation. The frequent issues of chimneys are Hairline Cracks and Shrinkage cracks. Industries use Maintenance and Inspection Experts to inspect Chimneys by using various risky methods like Ladder climbing, rope access and many more, accessing such a dangerous environment can be overcome by using U.A.V's for this process. We have developed a system to overcome this issue and additionally we also have air samples collector which helps to collect air samples released from chimneys and send samples for QA assessments to know the consequences. In this paper, a novel method by which copters identify the Chimneys structural cracks and get air samples released from chimneys is tested.

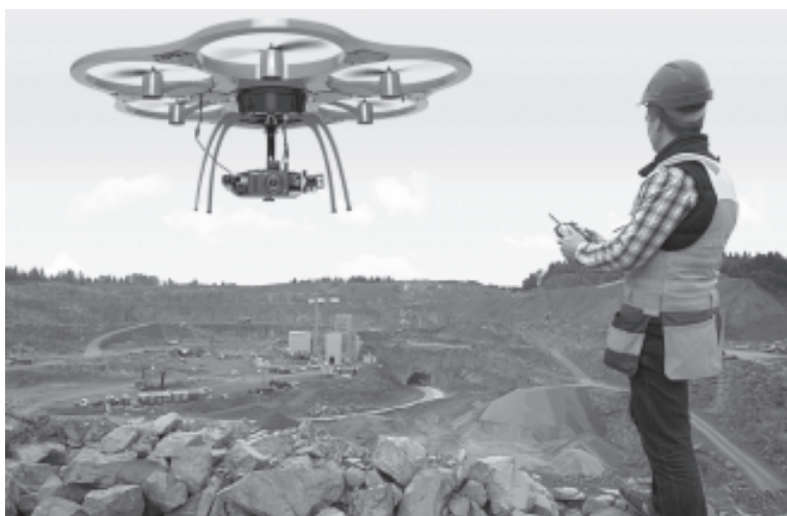
Figure 1: Aibotix® inspection copter

UAV multi rotors bear a potential of a great applications despite their limitations. One has to research on its capabilities and put to use to solve real world problems. Our research organization focuses on development of these drones for various applications in the industry. In this paper, we propose a method of how a drone can be used to solve problems encountered by industries/power plants bearing a stack/chimney. Industrial structures are subjected to inspection on a regular basis to ensure the safety of the workers and the people who stay nearby. For example, if a bridge has to be inspected, the entire bridge has to be shut down causing public inconvenience increase in traffic on the other routes, etc. This also involves a lot of manual labor and the method is risky, so deploying a UAV for this may prove to be an efficient method. Many UAV making companies are coming up with ideas such as aerial photography, photogrammetry but there were no special designs for inspection of buildings or structures until the recent past where Aibotix GmbH came up with power line inspections, quarry inspections.

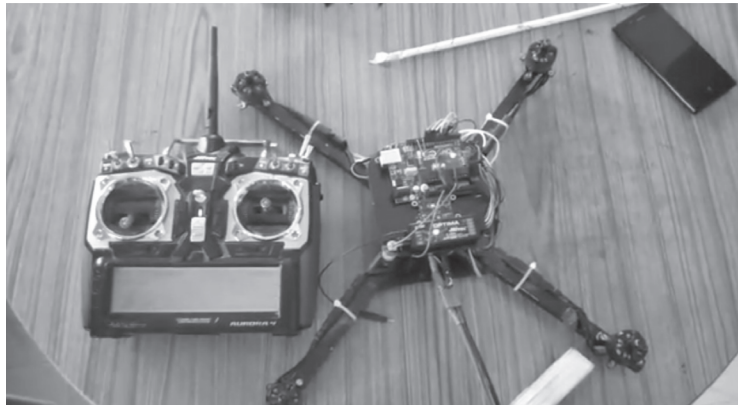
Our Quadrotor has been designed by using Components of the shelf like Arduino, IMU, Brushless motors, Battery and ESC with a control system running PID with simple Complimentary filtering. The frame we chose was an X configuration so that maneuverability becomes easy.

Figure 2: Fabricated Quadrotor

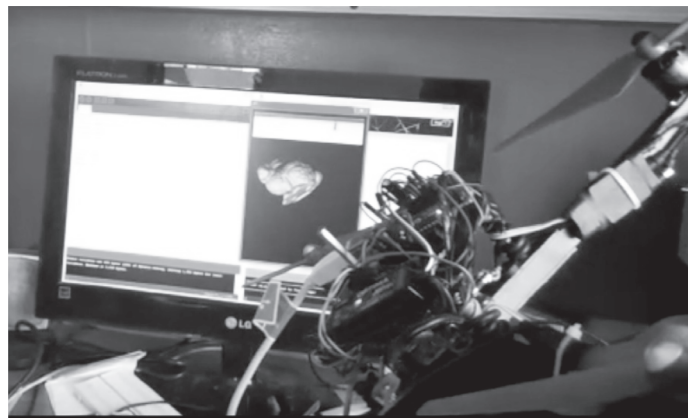
1. A Quadrotor with avionics system to record flight data.
2. A 2.4 Ghz R/C transmitter and receiver
3. A camera with a good resolution
4. A Ground Station Setup for analysis of images using MATLAB.

Figure 3: Ground Station Setup

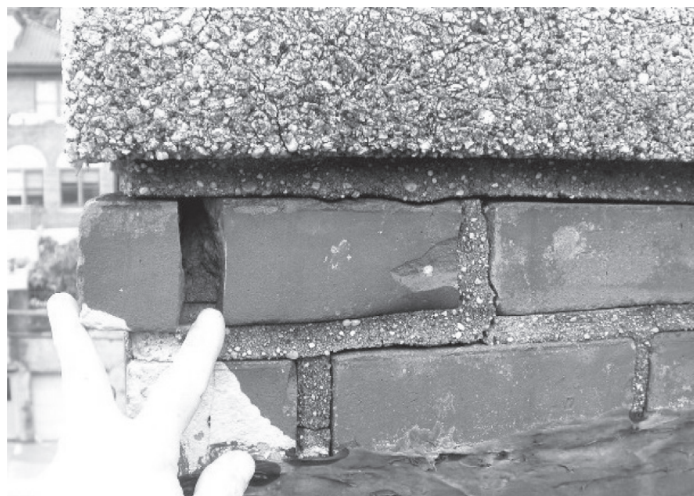
1. Improper construction: If there is no room left between the flue line and the masonry chimney sides, the heating up of the flue causes it to expand and sometimes crack up the surrounding brick.

Figure 4: Crack Resulted due to improper construction

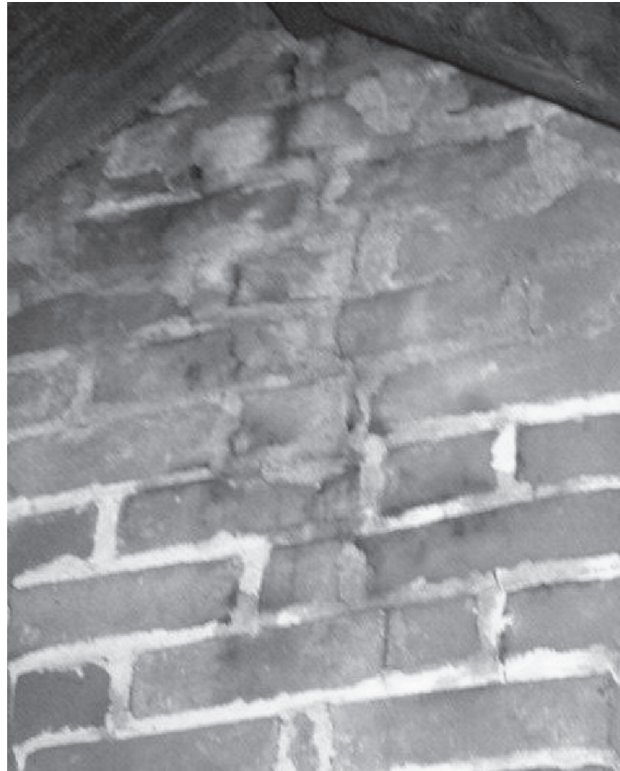
2. Water leaks: Faulty chimney top seal/rain cap may cause the water to seep into the structure and result in cracks.
3. Chimney movements: Improper securing of the chimney to the building or defective foundation may lean; bend the structure. In tall stack structures, the high speed winds that exert pressure on one side of it may lead to varying stress. This may result in cracks at the mortar joints of brick masonry.
4. Thermal expansion: This is most common reason for cracks. It arises due to improper construction of the brick masonry where enough room is not left for the structure to expand or contract leading to variable stress and cracking.

Figure 5: Cracks caused due to seepage of water

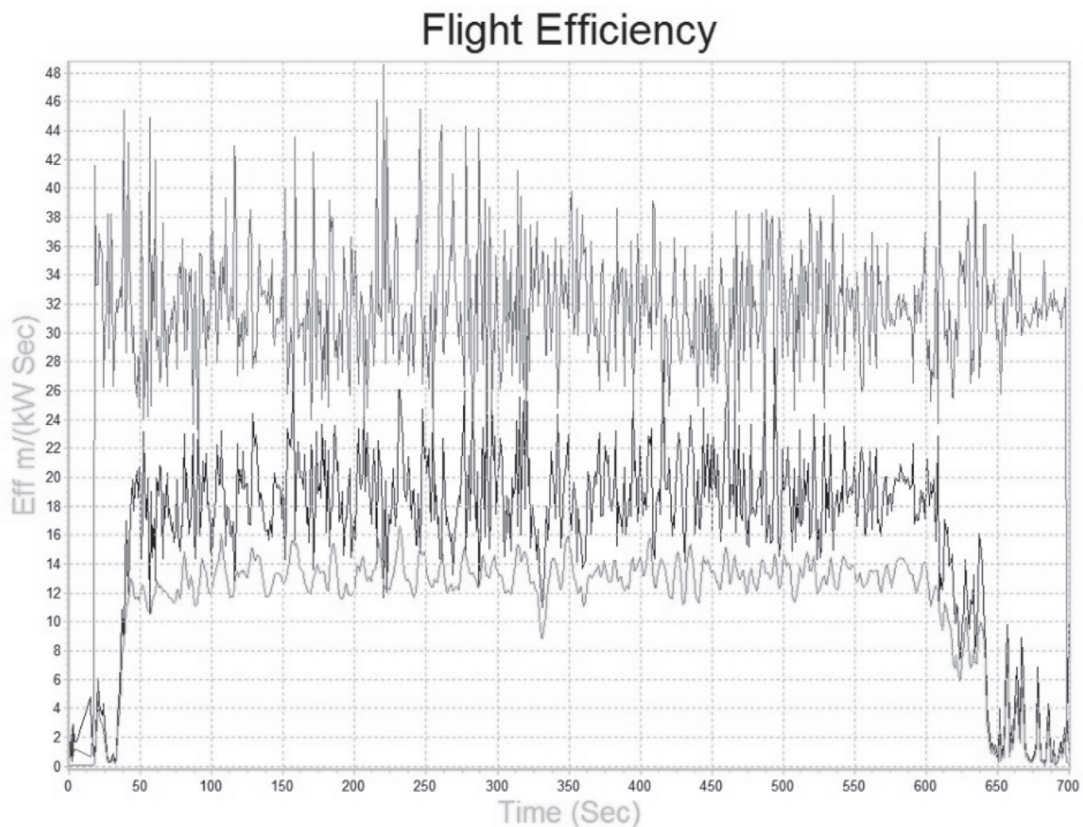
The efficiency of this method also involves the flight efficiency. To determine this we created a graph using t-chart package where the extracted data from the logger that is a part of onboard avionics is plotted against time. The purple plot represents energy consumed by GPS flight. Instantaneous power is represented by the green line where units are Watts/10. The black line on the graph is the distance efficiency or how many meters the Quadrotor is covering for every kiloWatt second of energy being used.

Figure 14: Efficiency of the flight tested during a headwind

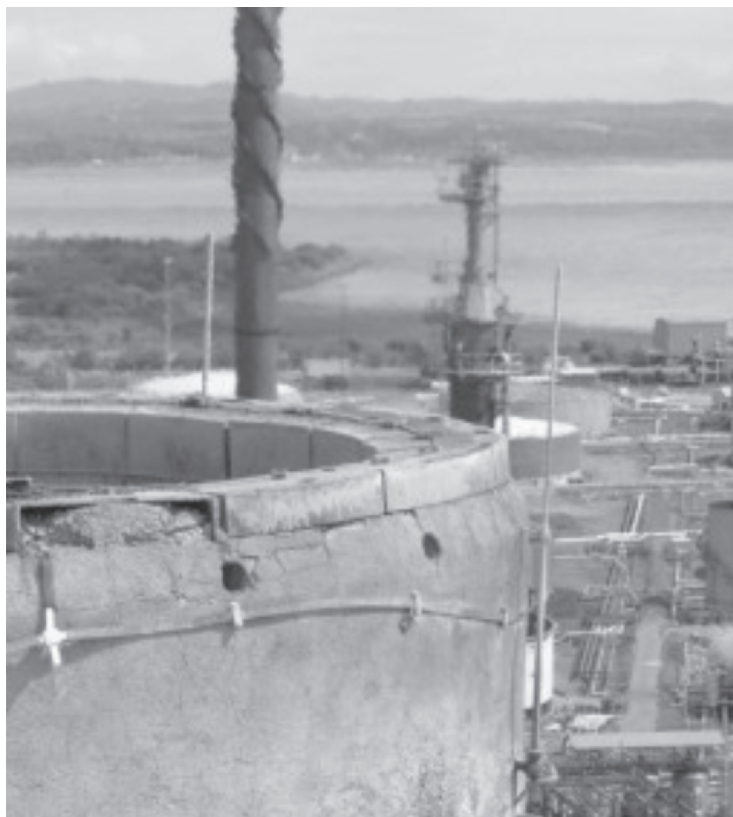
Figure 15: Copter inspecting a stack, about 300 meter high

A method proposed to determine cracks in industrial chimneys/stacks is tested and a novel approach in detection of cracks was derived. Our simple design employed in the construction of the Quadrotor was able to carry out the mission task successfully. We also achieved a greater altitude as well as greater flight time as compared to the normal design which includes a bunch of other sensors. However, this was at compensation of live telemetry. We were able to inspect an industrial stack made of RCC of about 300 meter high.

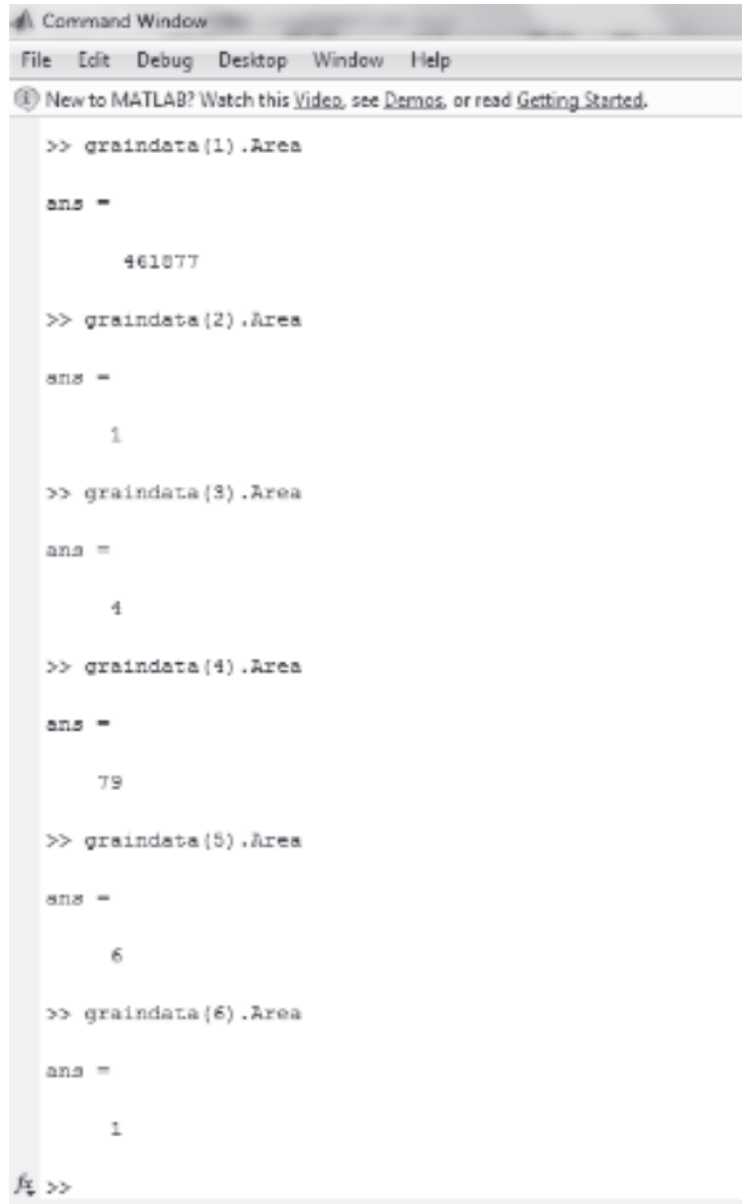
>> graindata(1).Area
ans =
    461877
>> graindata(2).Area
ans =
     1
>> graindata(3).Area
ans =
     4
>> graindata(4).Area
ans =
     79
>> graindata(5).Area
ans =
     6
>> graindata(6).Area
ans =
     1
fx >>
```

Figure 17: Result of our experiment for the above figure 16, the area of crack is determined in number of pixels
