International Journal of Control Theory and Applications

Volume 10 • Number 16 • 2017

Power Transformer Fire and Explosion: Causes and Control

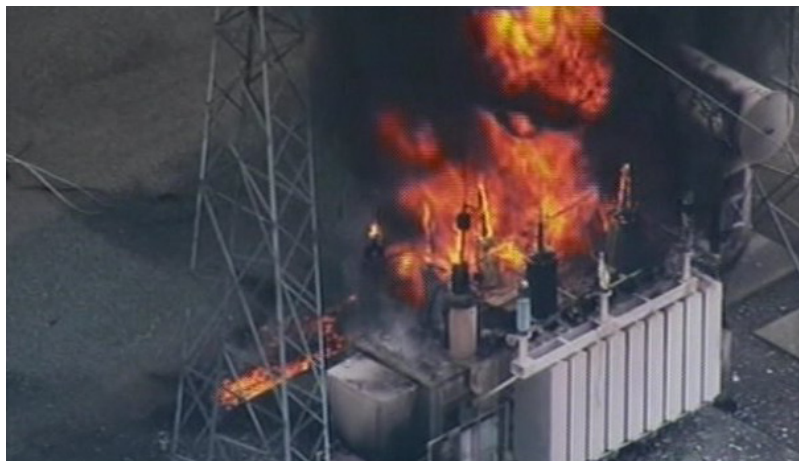
Figure 2: Fire due to mineral oil from a high voltage transformer
(<http://www.nbcrightnow.com/story/14924340/>)

transformers occur the power utility loses its integrity with the government and public, and the consequences are economical as well as environmental including pollution of water supply by the spilt oil. In addition to the failure of energy supply with the collapse of the transformer and the consequent economic loss. The additional consequences includes the shattered bushing ceramic pieces damaging other equipment, buildings and putting people at risk, the pressure built up by the explosion impacting other structures, the leaking insulating oil fire lighting up the combustible materials and structures. Also the heat flux causing failure of electrical and electronic systems, steel structures collapsing due to the heat generated, the fire plume from the burning transformer creating a charged atmosphere under overhead lines leading to flash over and line to ground or line to line faults (Figure 2).

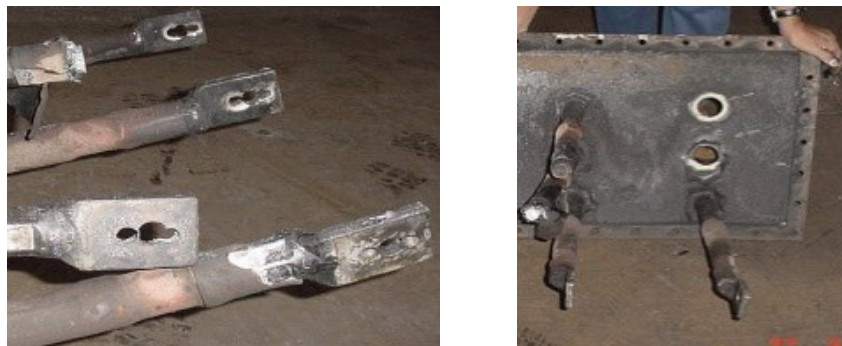
Figure 3: Bolt holes of the lug of the transformer destroyed by fire (www.lankaweb.com)

- Poor mechanical contacts at bushings leading to sparks, loose springs in the tap changing contacts, pitted contacts of tap changer, fire in vapor accumulating above the oil, bad maintenance practice and condition monitoring (Figure 3). Improper lug connections, and terminals tightened without locknuts, result in the connections becoming loose with time, and when high starting currents, for instance, of motors pass through the loose connections spark occur which may ionize the chamber resulting in explosions [6].

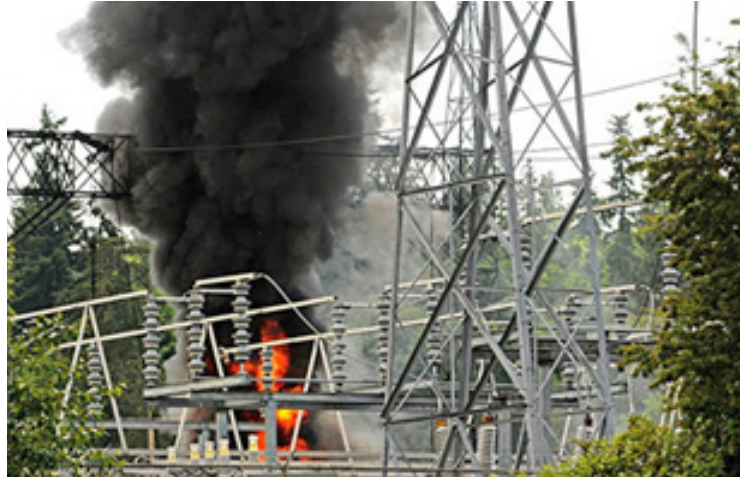
Figure 4: Overhead structure fire that cause metal structures to sag and collapse.
(<http://electrical-engineering-portal.com/arriving-at-the-scene-of-a-power-substation-fire>)

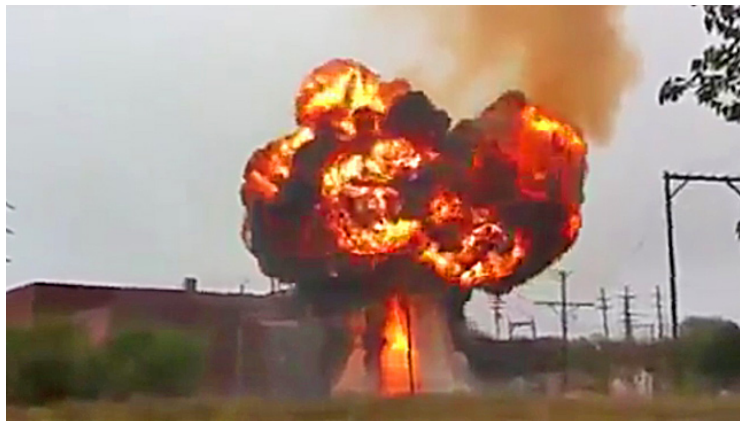
Figure 5: Transformer explosions (<http://video.news.com.au/v/75639/>)

Causes of transformer explosion (Figure 5) are [8-9]:

- Hydrogen and methane gases produced as the high energy arc gasifies the oil.
- Pressure builds up above the oil level leading to transformer tank or cover being blown out. The pressure relief devices are unable to handle suddenly increasing pressures.

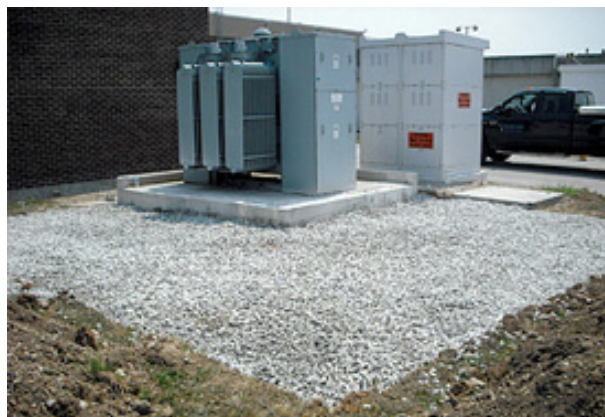
Figure 6: Transformer oil containment (<http://www.transformer-oil-containment.com/>)

The aim of passive fire protection is to prevent or limit damage to adjacent equipment due to the electrical failure in transformer [13]. There are three construction features considered such as oil catchment areas, heat radiation barriers and oil drainage system. The oil catchment area is constructed to avoid discharged oil from flowing across non-absorbent ground surface (Figure 6). This area is provided around major transformers and auxiliary transformer where any oil discharged is confined within the catchment area and reduced the potential of burning oil from endangering the main transformer respectively. By connecting the auxiliary oil catchment area to the catchment area for the main transformer, a lower bund wall is needed. The bund wall is also used to separate the oil cooler bank and main transformer.

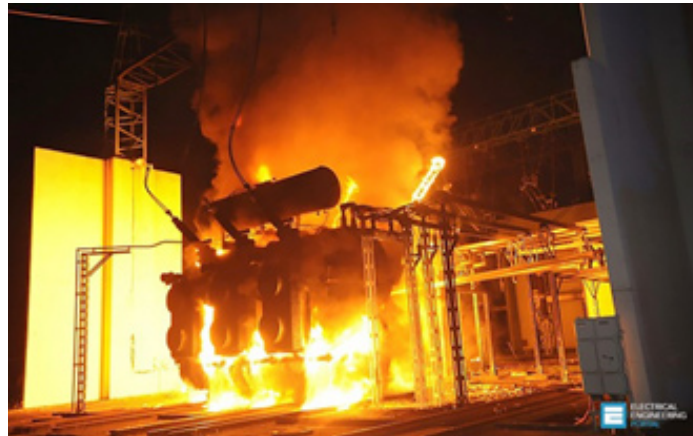
Figure 7: Firewalls containing the transformer fire
(<http://electrical-engineering-portal.com/substation-fire-protection>)
